HALLMARK BUILDING SUPPLIES, INC. FIRE TEST REPORT

ASTM E84 TESTING ON INTERLOCKING PANELS, MODEL LDC-419

103953780SAT-001A

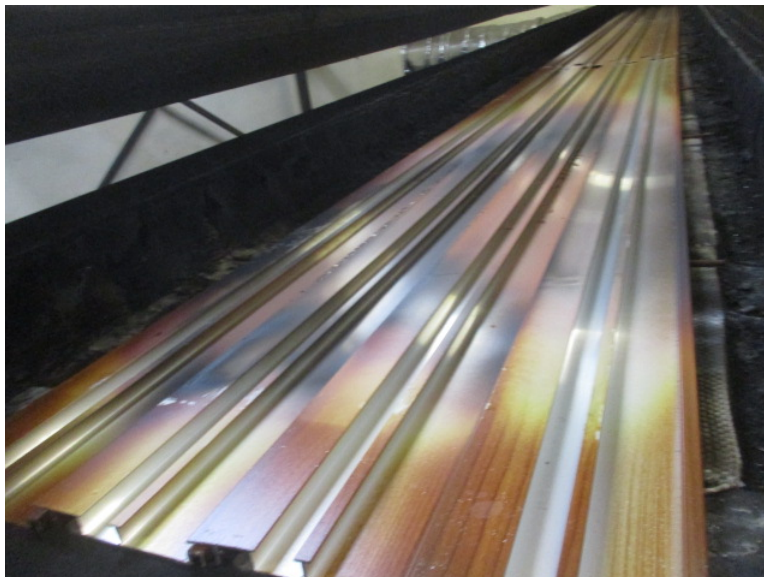
Photo No. 4
Unexposed Surface of the Test Specimen (Post-test)
